**District  
of Columbia  
Public  
Schools**

**Facilities Assessment**

**Langley Junior High  
#418**

**3DI/AEPA  
August 3, 1992**

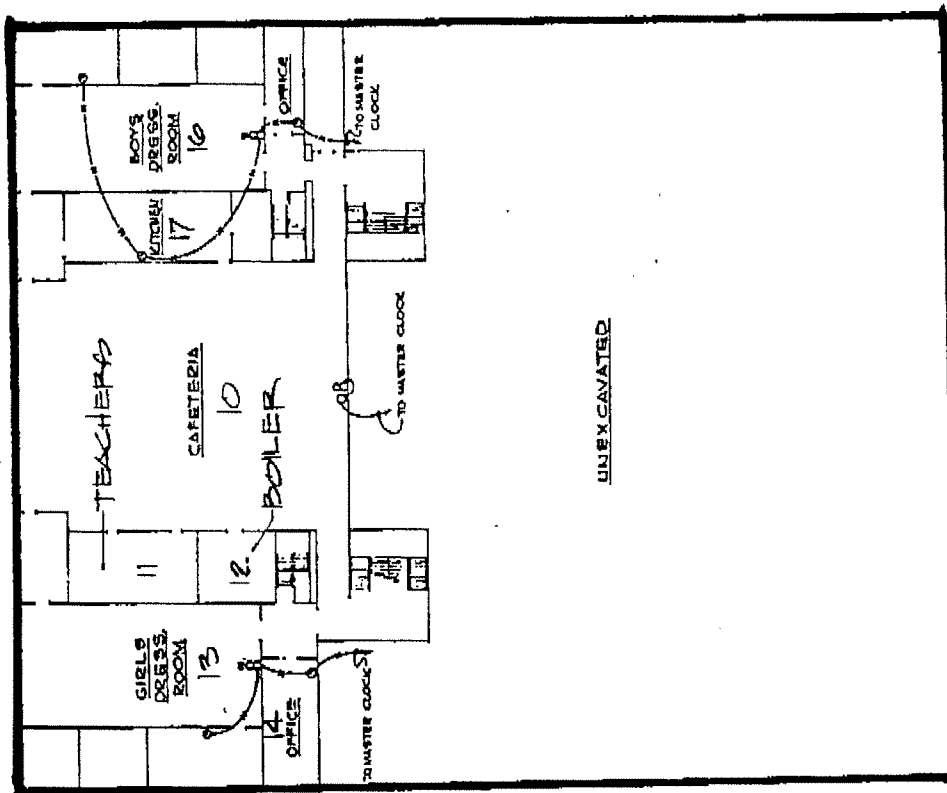
3DI/AEPA	Date 11/6/92	School No. 418/J.H.
DC Public Schools Facilities Assessment Survey	SITE PLAN	LANGLEY JR. HIGH SCHOOL

BROKEN LIGHTS
